CSP North Baltimore Paint Conveyor System Health Assessment

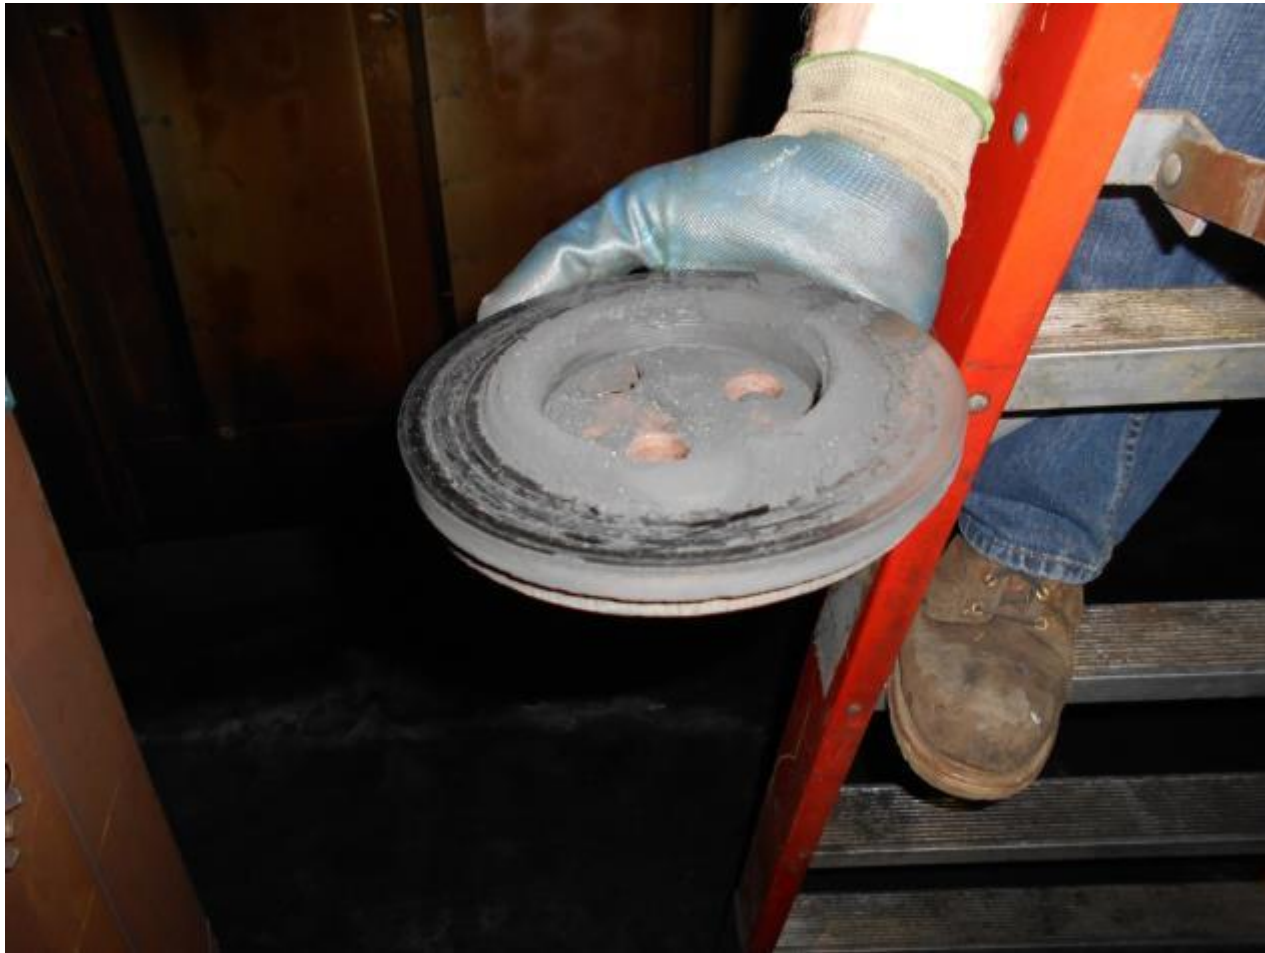
Traction wheel keeper plate with Graphalloy thrust washer upon first removal

Considerable amount of Graphalloy dust and shavings from worn hub and thrust washer was present upon initial removal

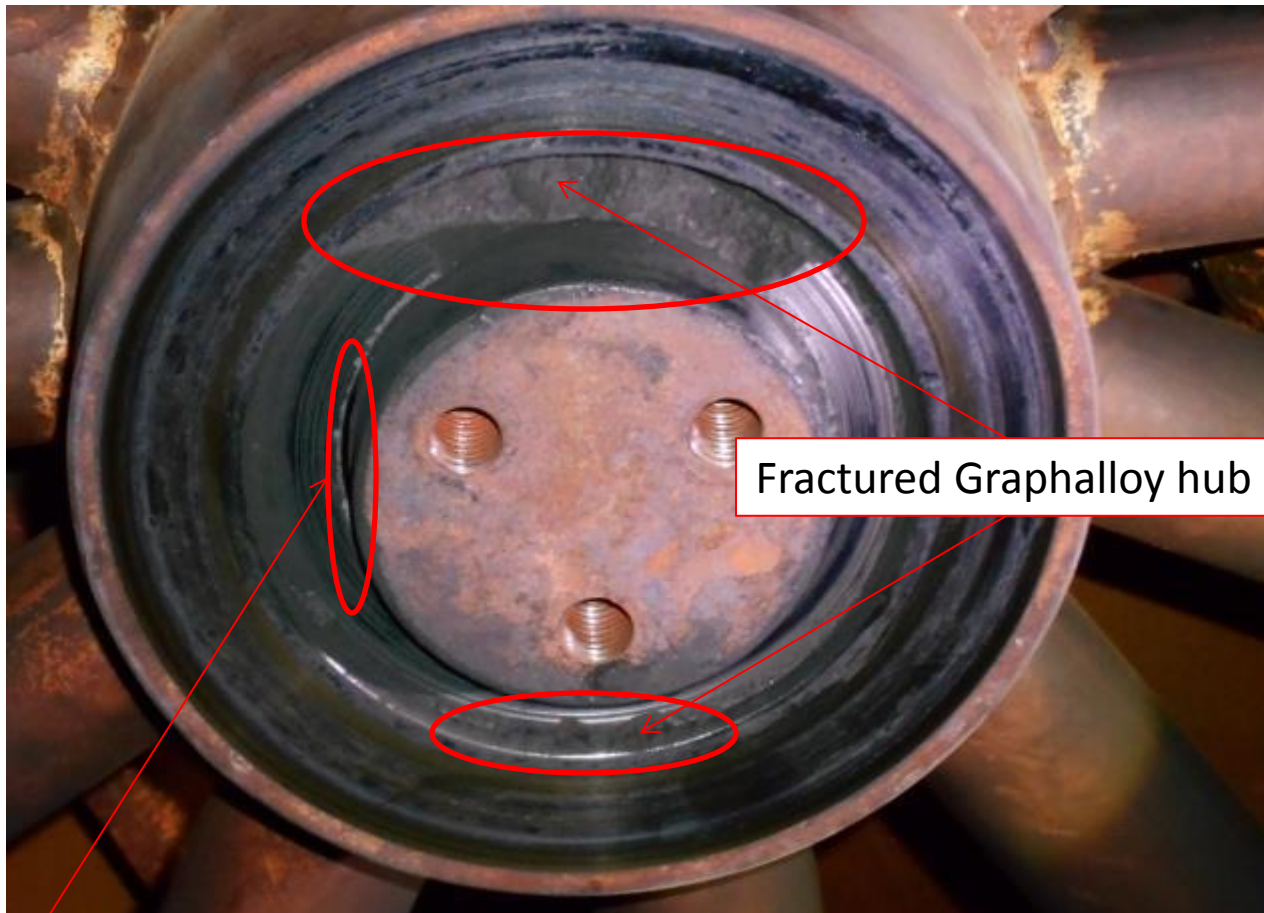
Oven traction wheel with keeper plate removed for Graphalloy hub inspection

Fractured Graphalloy hub

Air gap between worn Graphalloy and shaft suggests excessive wear

- An active lubrication system is critical for all paint conveyor systems. Installing a working system will greatly help alleviate the current torque overload issues.
- **An active automatic conveyor chain lubrication system should be the immediate top priority.**
- We recommend replacing all of the Graphalloy hubs on the traction wheels throughout the paint bake oven
- The north conveyor stand by drive unit is inoperable and at a minimum will require new cat chain sprockets, new back up bars, and a new cat chain

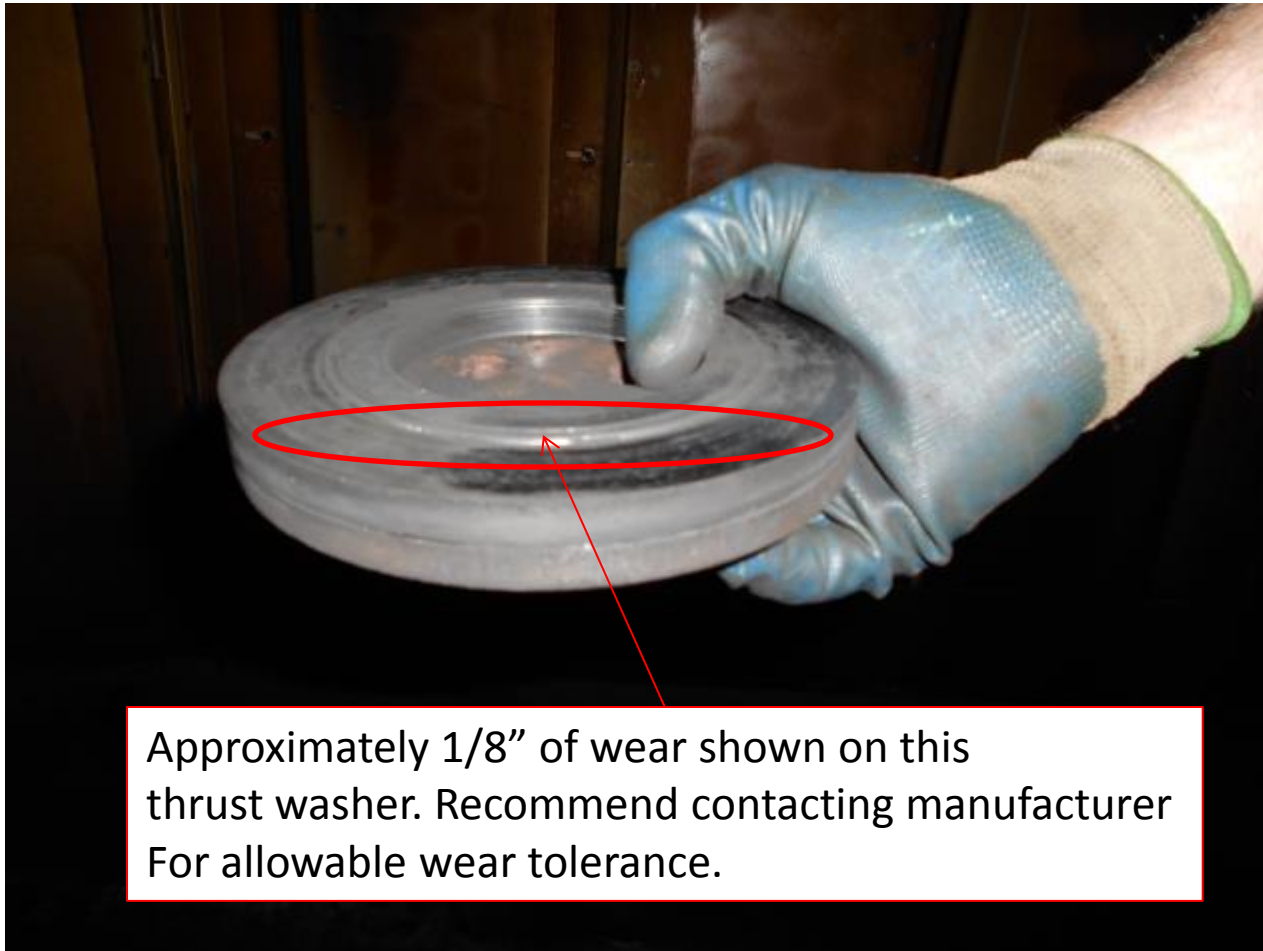
Traction wheel keeper plate with Graphalloy thrust washer

Approximately 1/8" of wear shown on this thrust washer. Recommend contacting manufacturer For allowable wear tolerance.

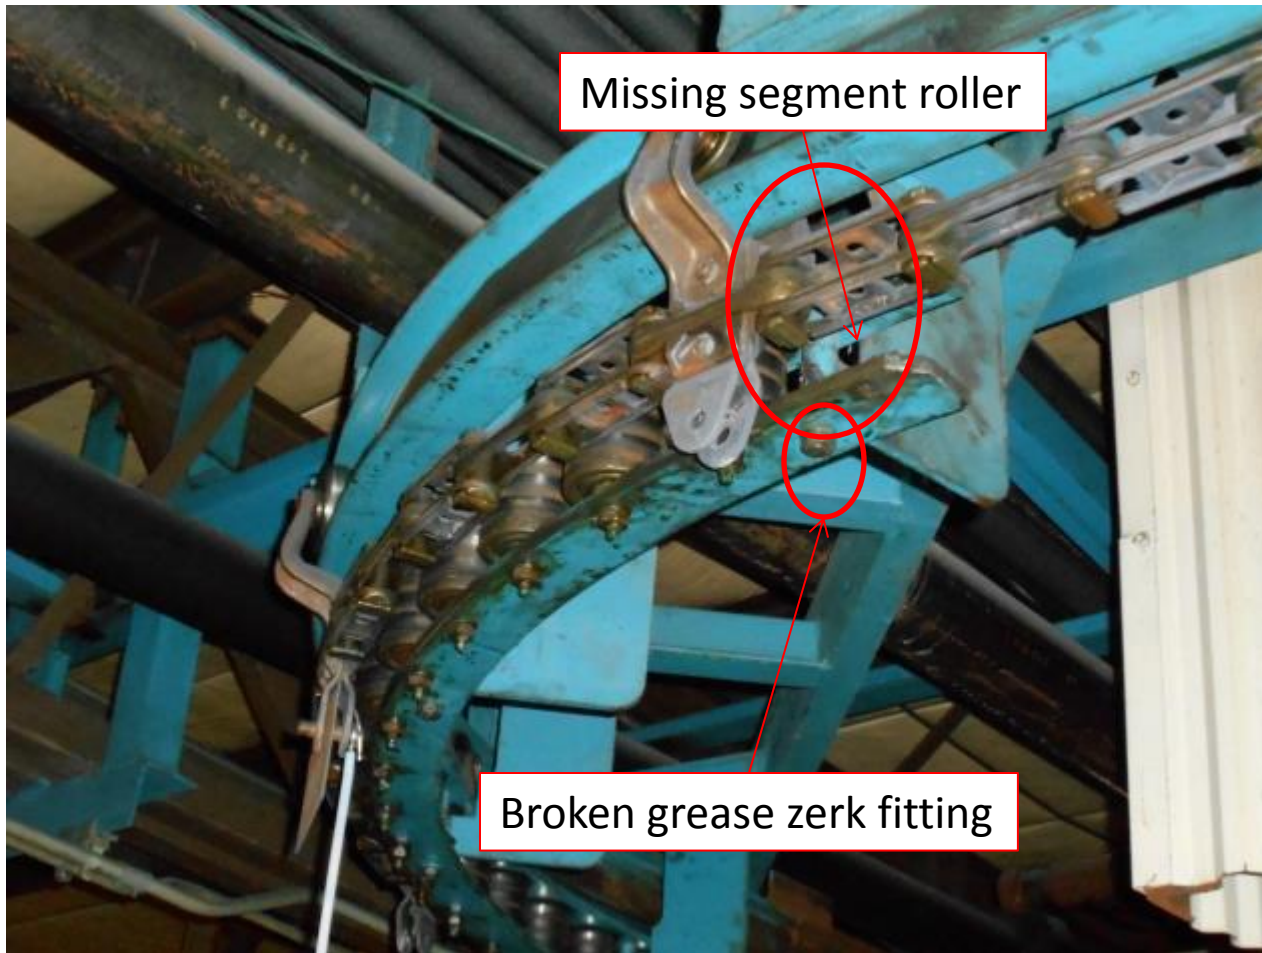
Segment roller turn #1

Missing segment roller

Broken grease zerk fitting

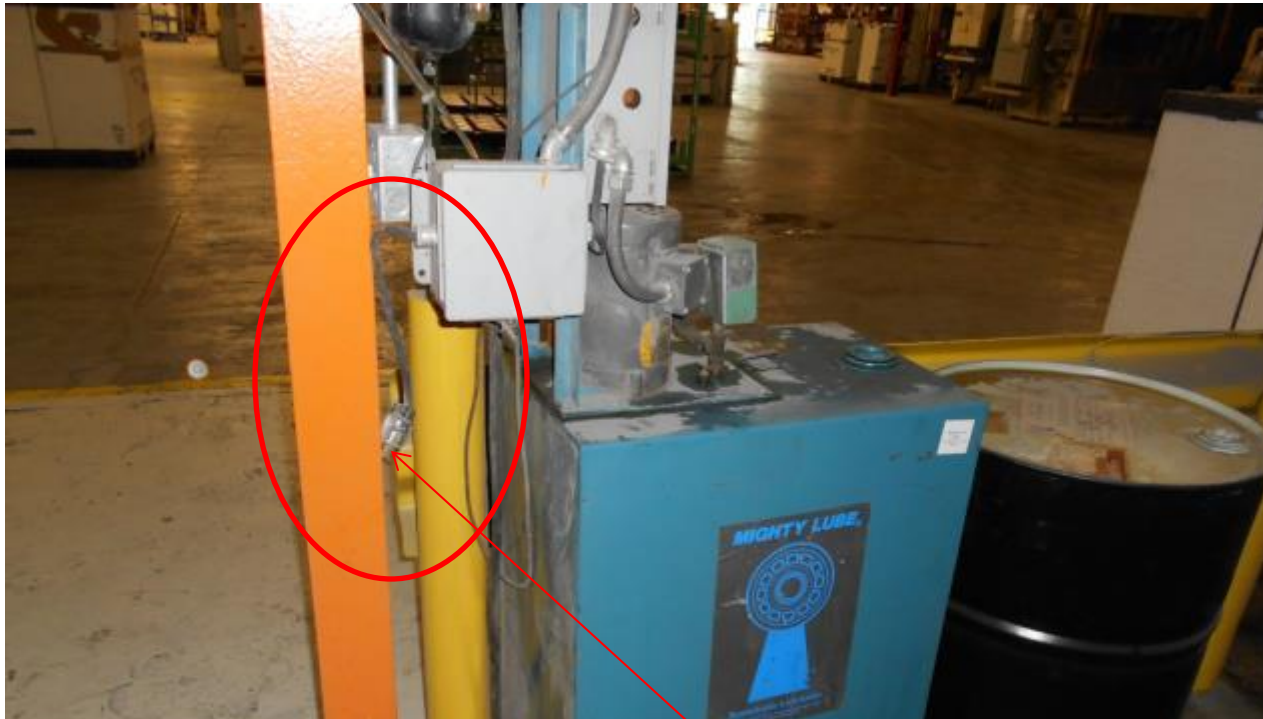
Conveyor chain lubrication system

System is disabled. It was mentioned that this is a legacy Lubrication system and parts are no longer available. This System has a broken circuit board that has been out for Repair for the last 8 weeks. Lack of lubrication is a **MAJOR** issue on this type of conveyor system.

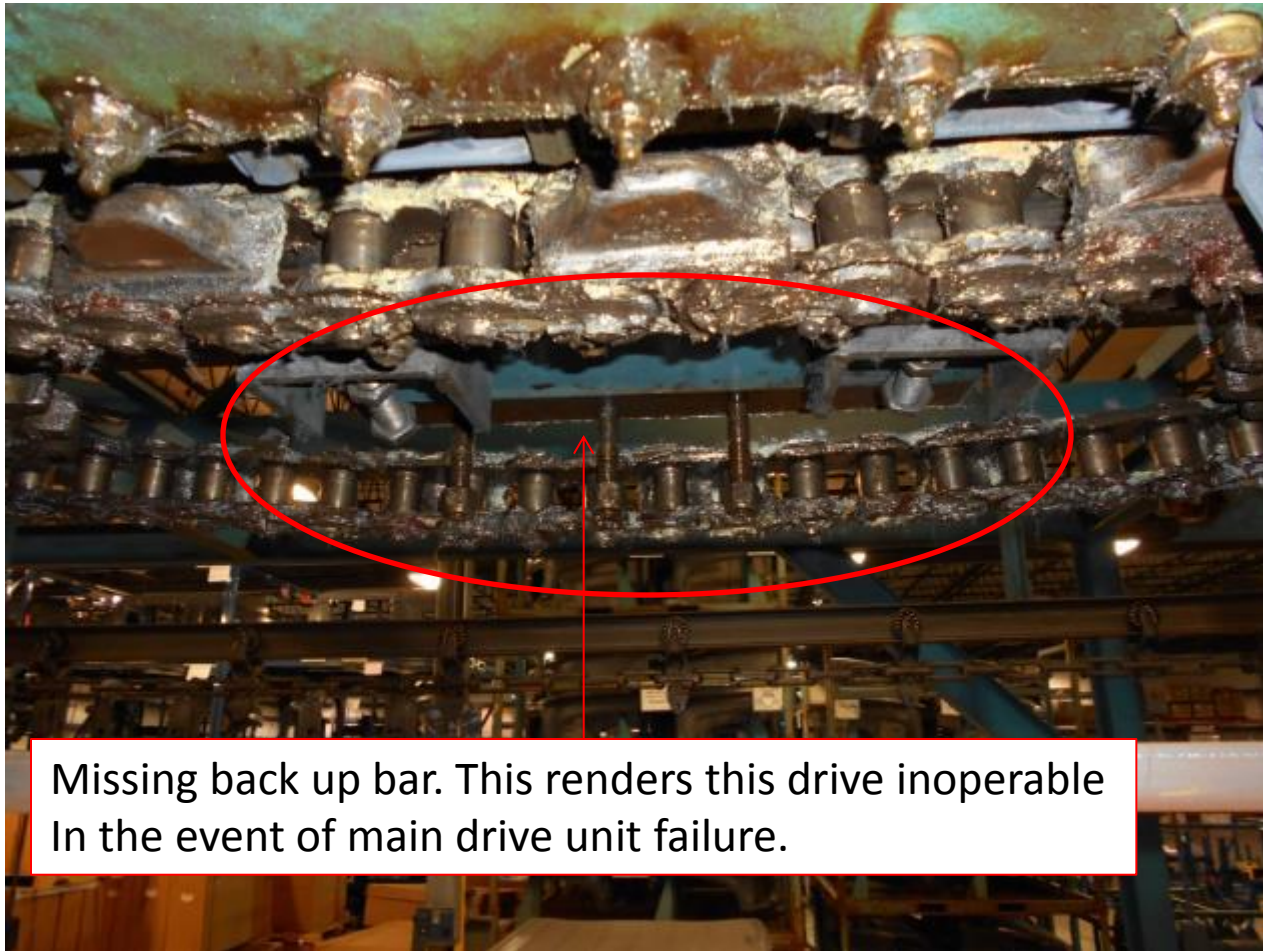
North conveyor drive (back up unit)

Missing back up bar. This renders this drive inoperable
In the event of main drive unit failure.

- We recommend replacing all conveyor drive (main and stand by on both north and south drives) cat chain sprockets, cat chains, and back up bars
- We recommend installation of an automatic cat chain lubrication system on all (4) drive units
- Due to lack of sufficient time to perform a complete system inspection we were unable to physically inspect all of the segment roller turns in the system.
- We recommend that all roller nests are physically inspected for worn out bearings and that new replacement rollers are installed and lubricated where deemed necessary.

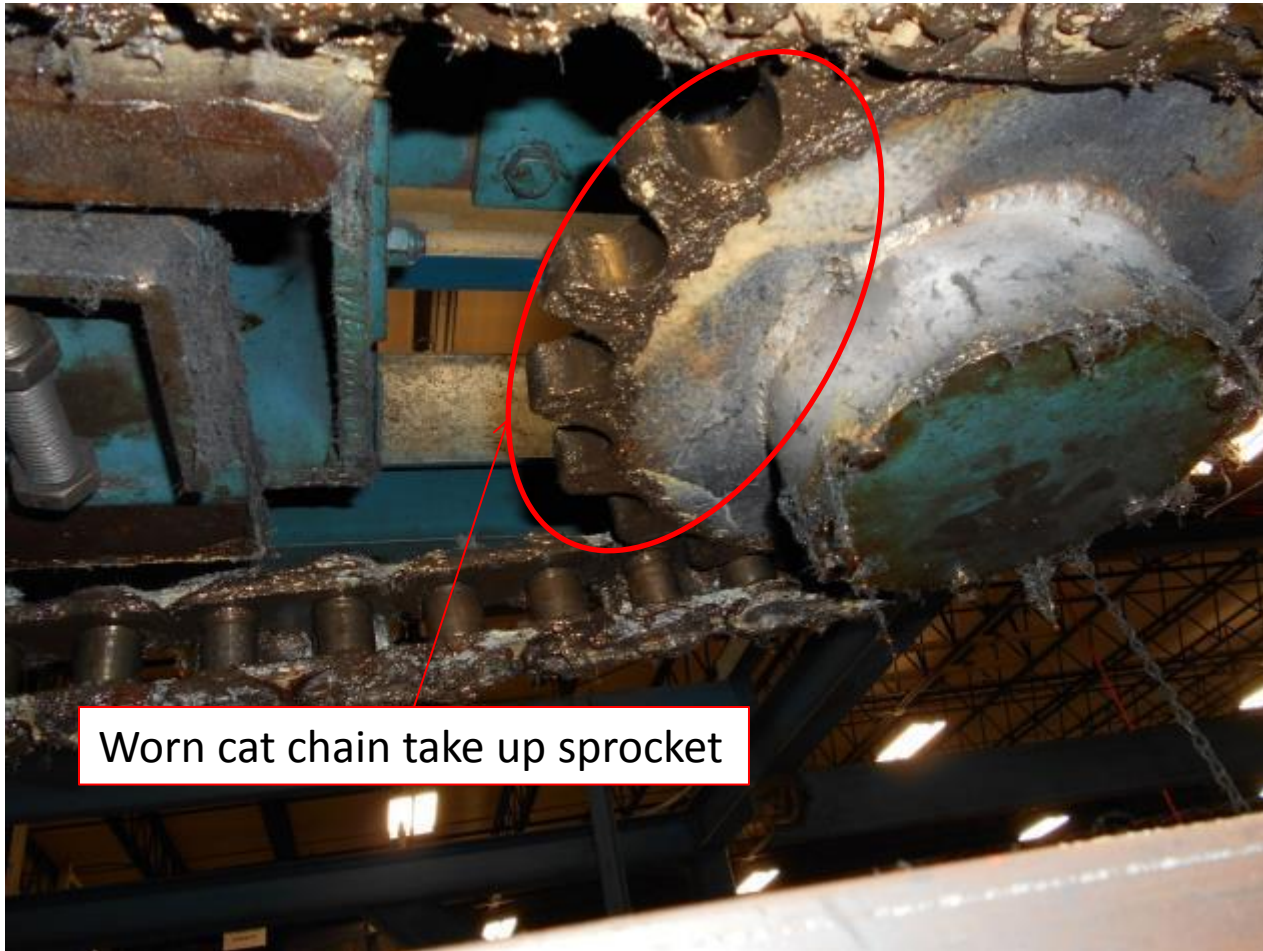
North conveyor drive (back up unit)

Worn cat chain take up sprocket

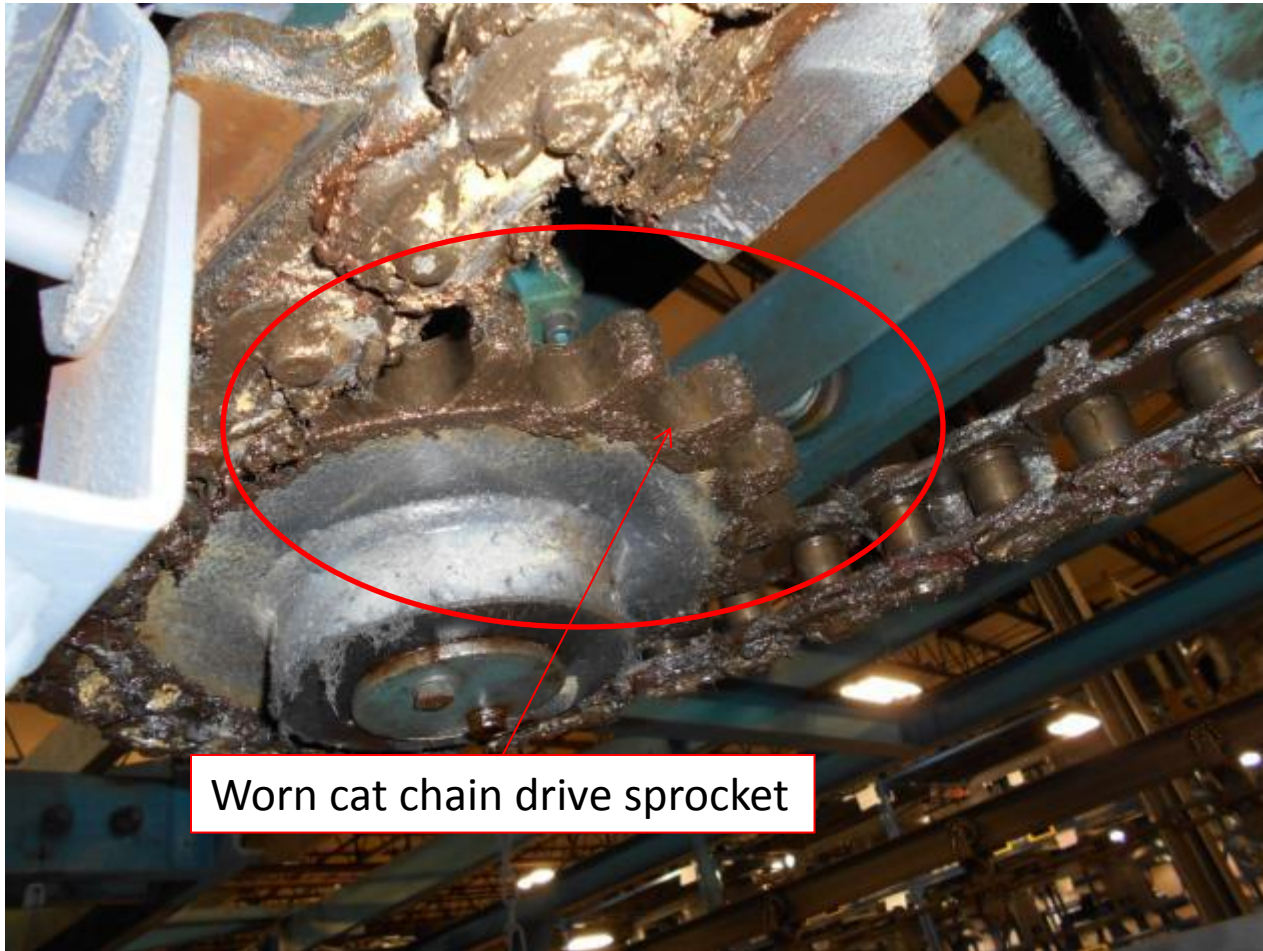
North conveyor drive (back up unit)

Worn cat chain drive sprocket

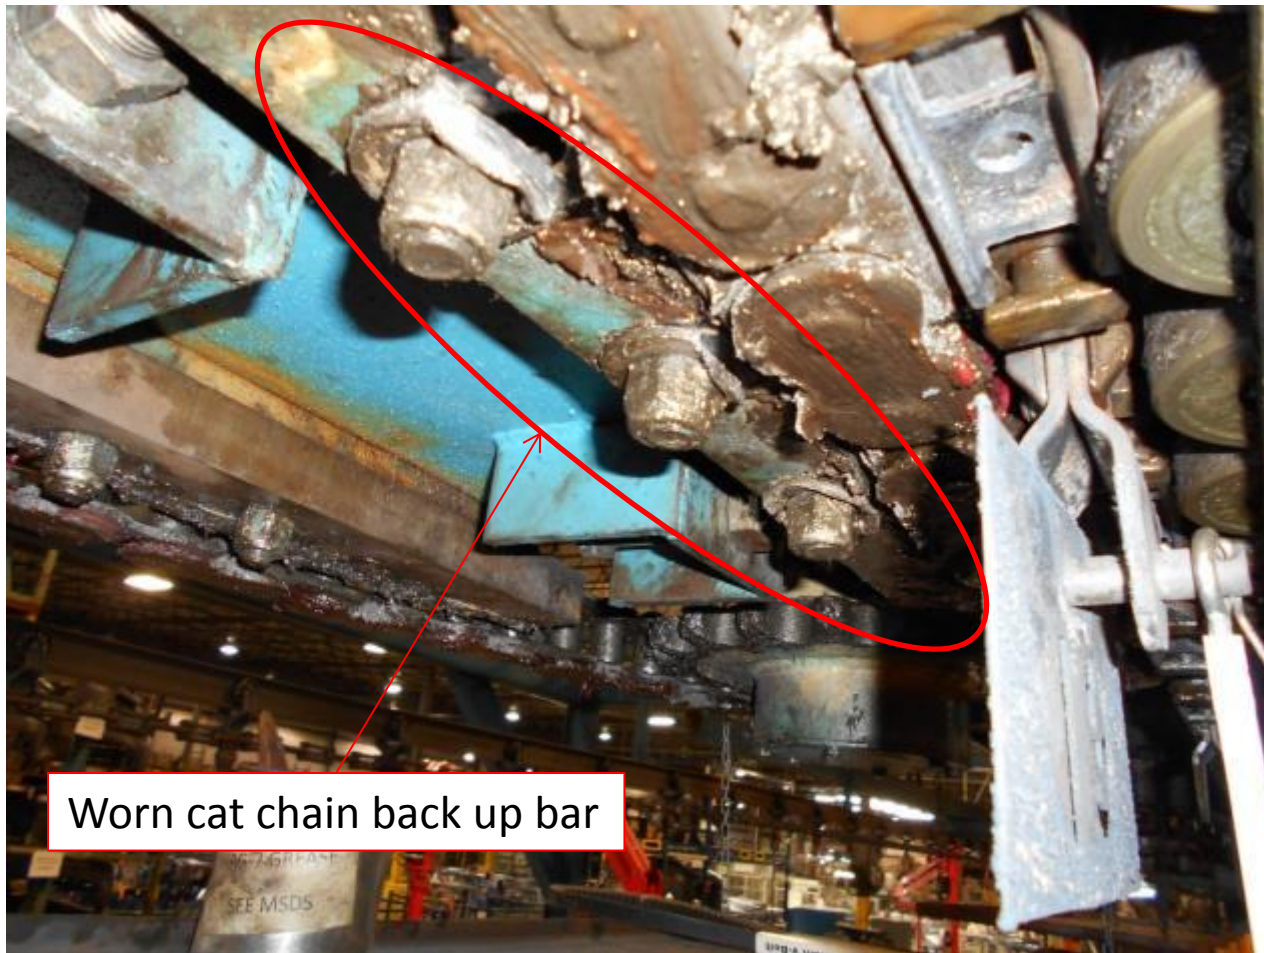
North conveyor drive (main unit)

Worn cat chain back up bar

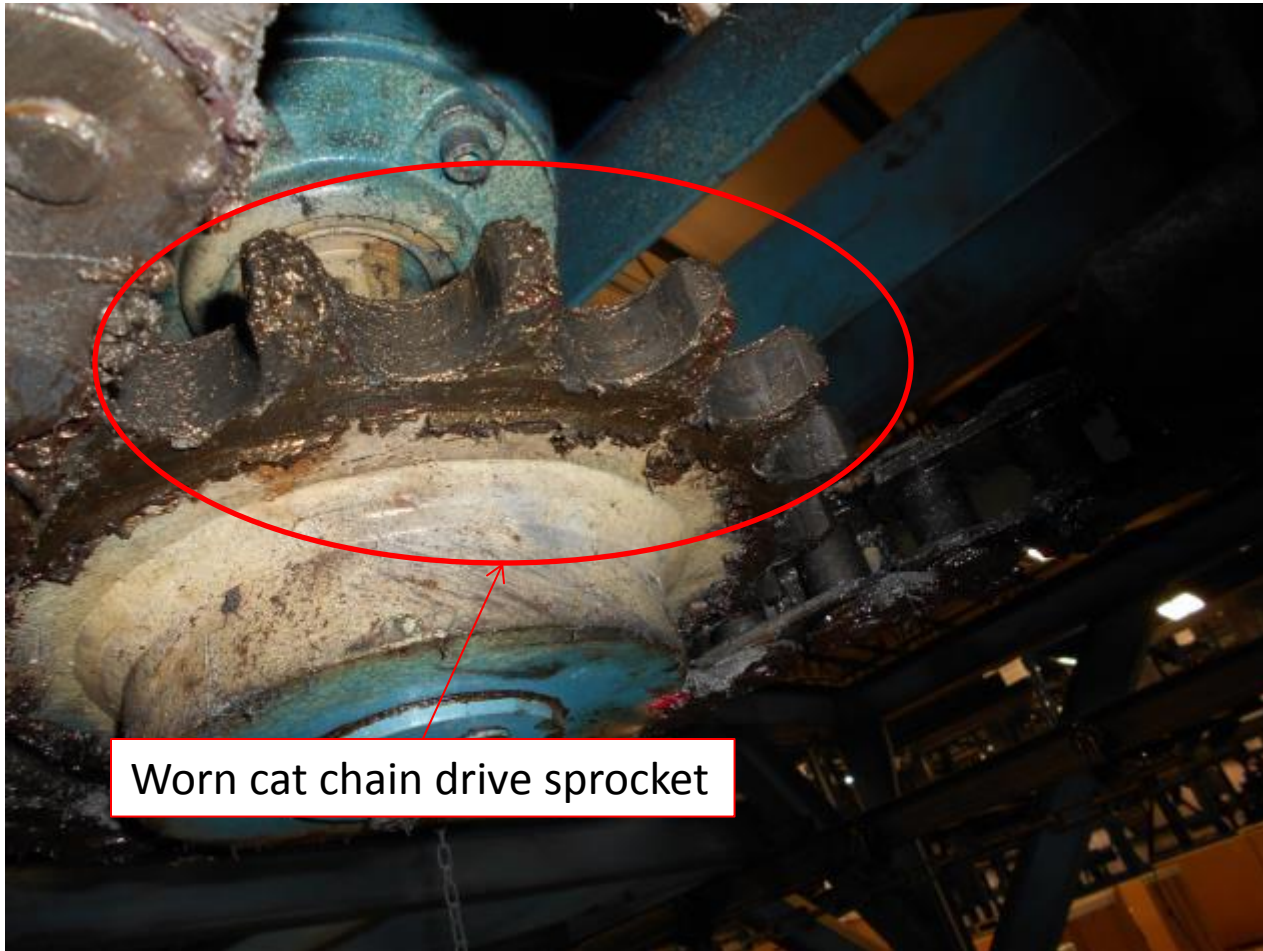
North conveyor drive (main unit)

Worn cat chain drive sprocket

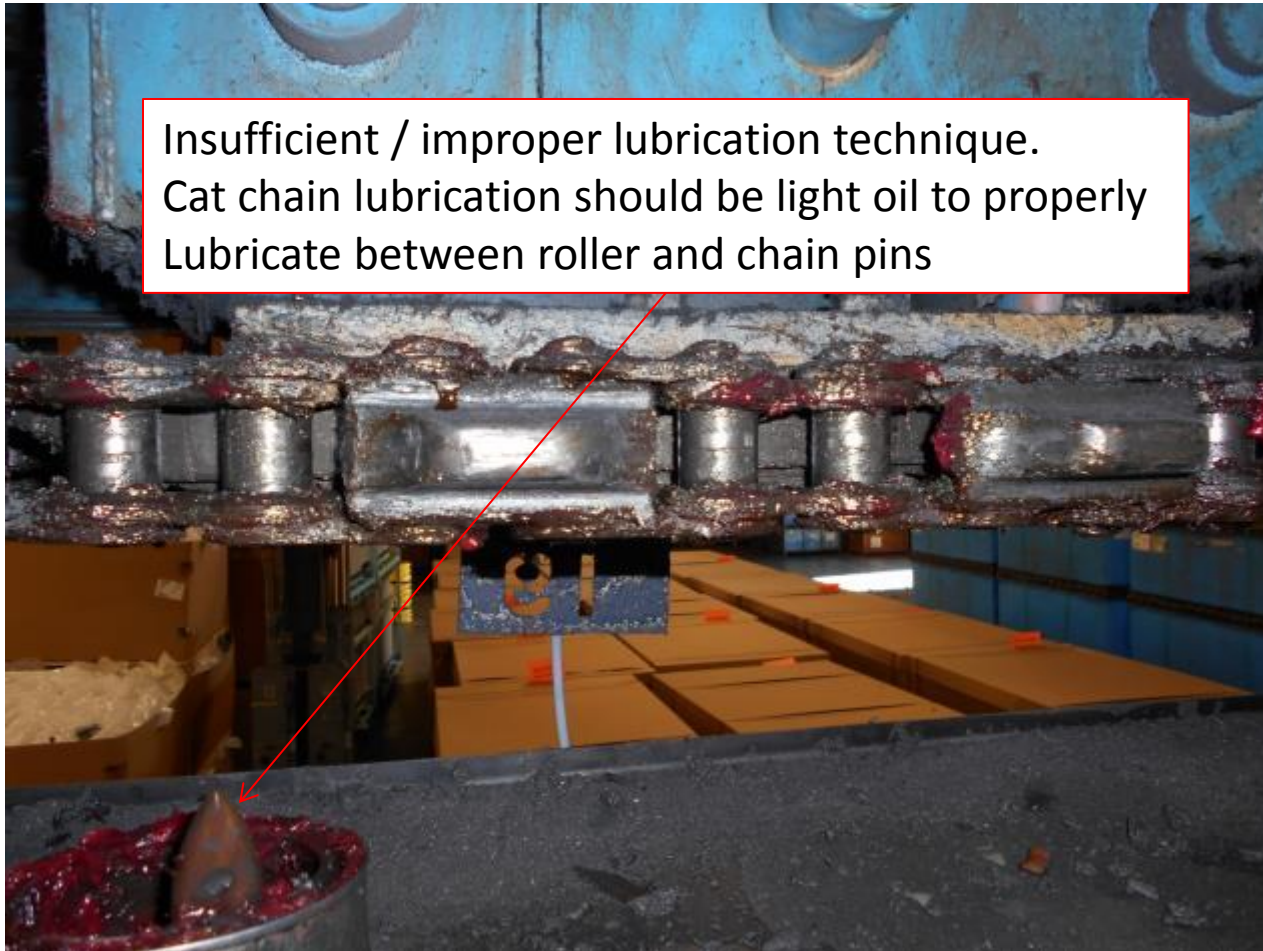
North conveyor drive (main unit)

Insufficient / improper lubrication technique.
Cat chain lubrication should be light oil to properly
Lubricate between roller and chain pins
