CSP North Baltimore Paint Conveyor System Health Assessment

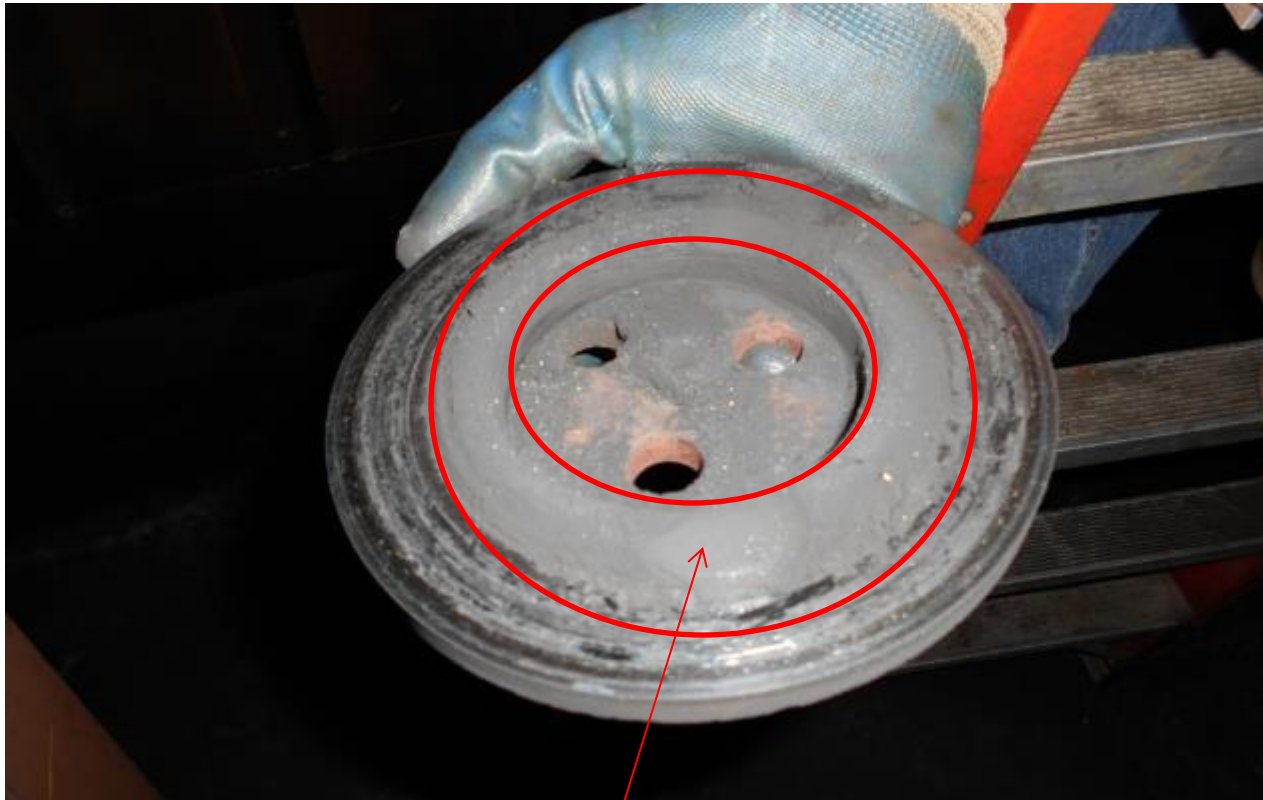
Considerable amount of Graphalloy dust and shavings from worn hub and thrust washer was present upon initial removal

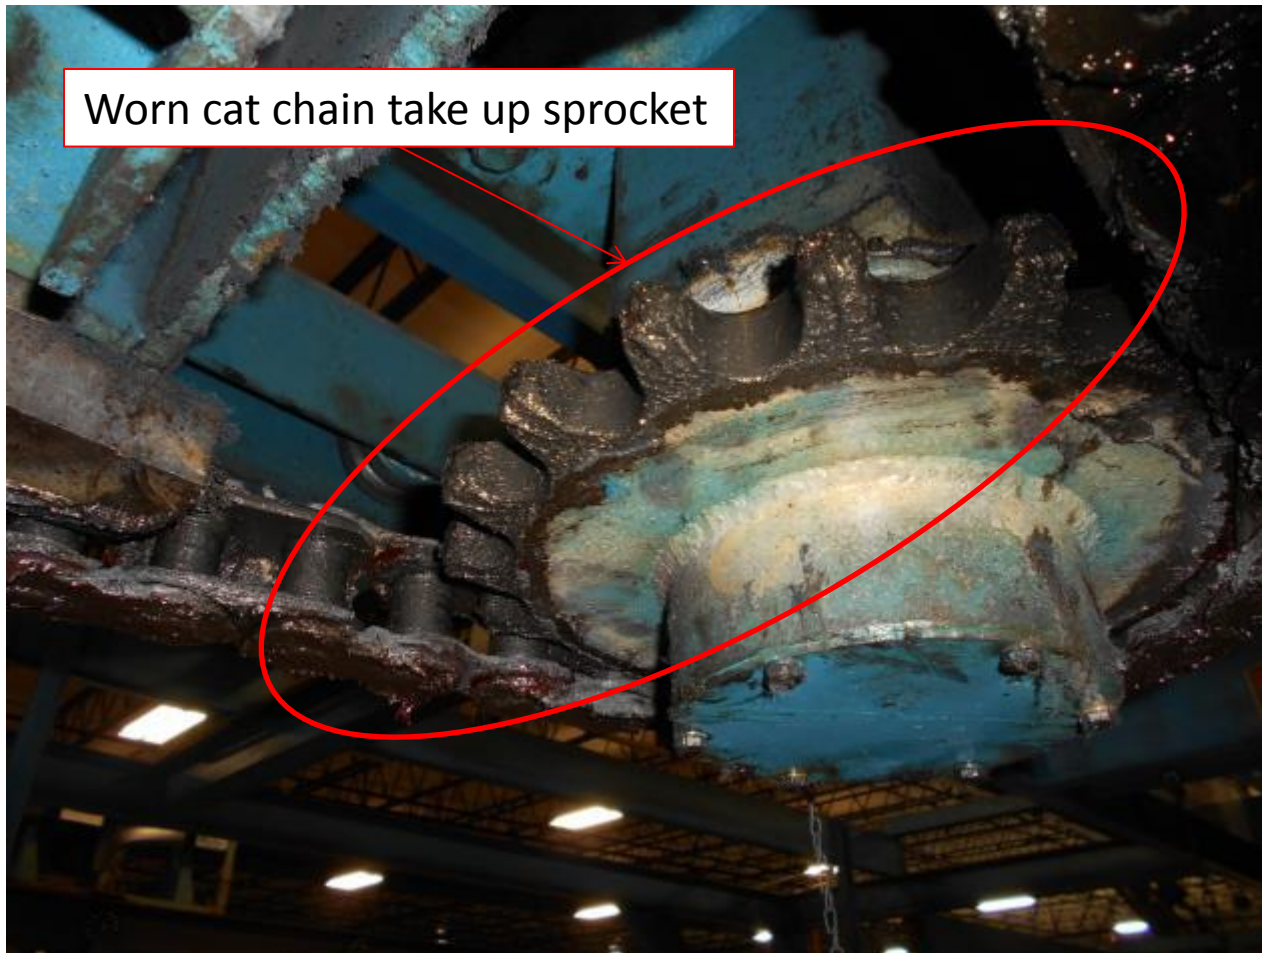
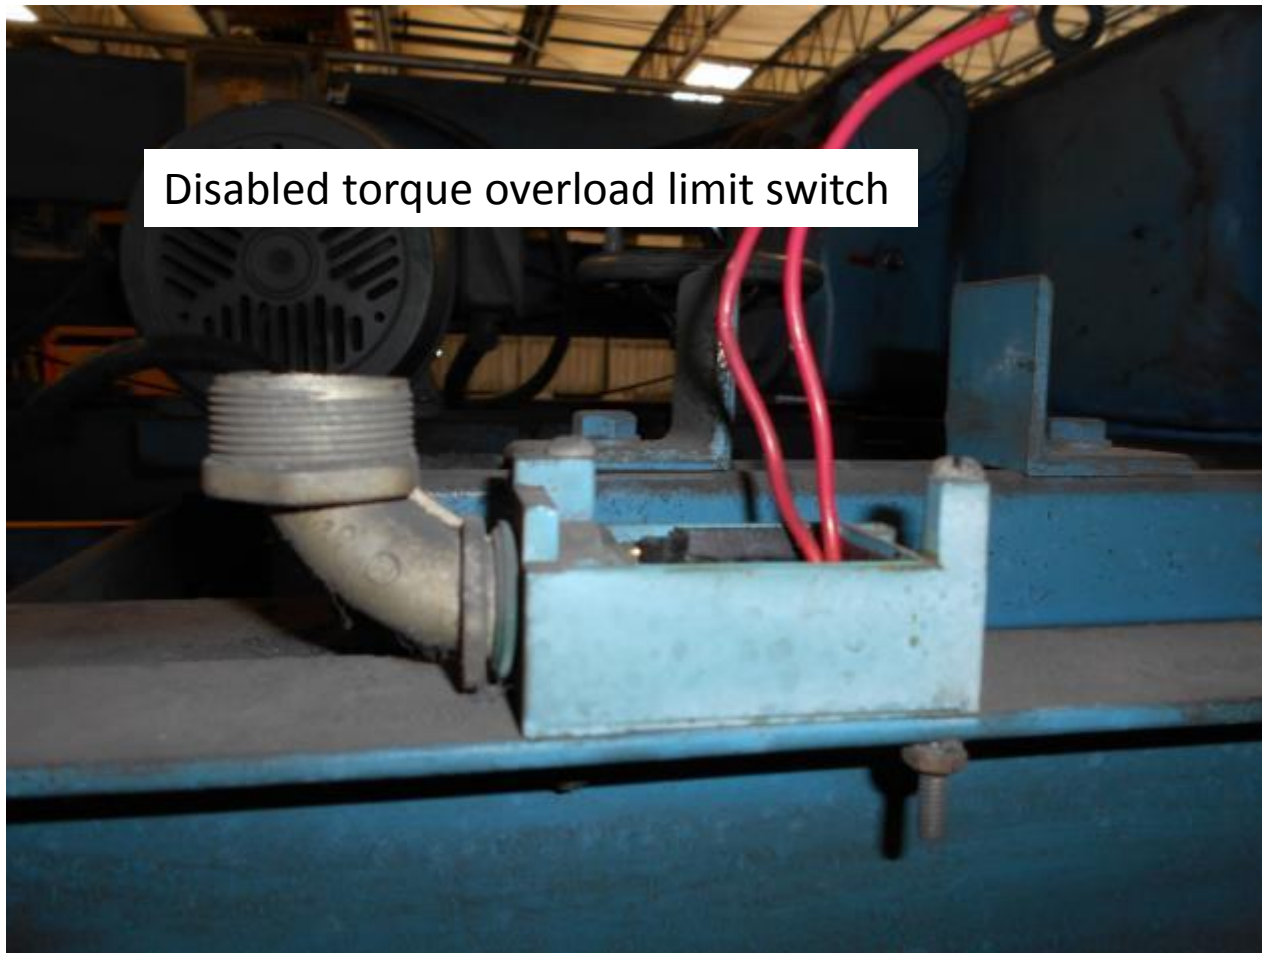
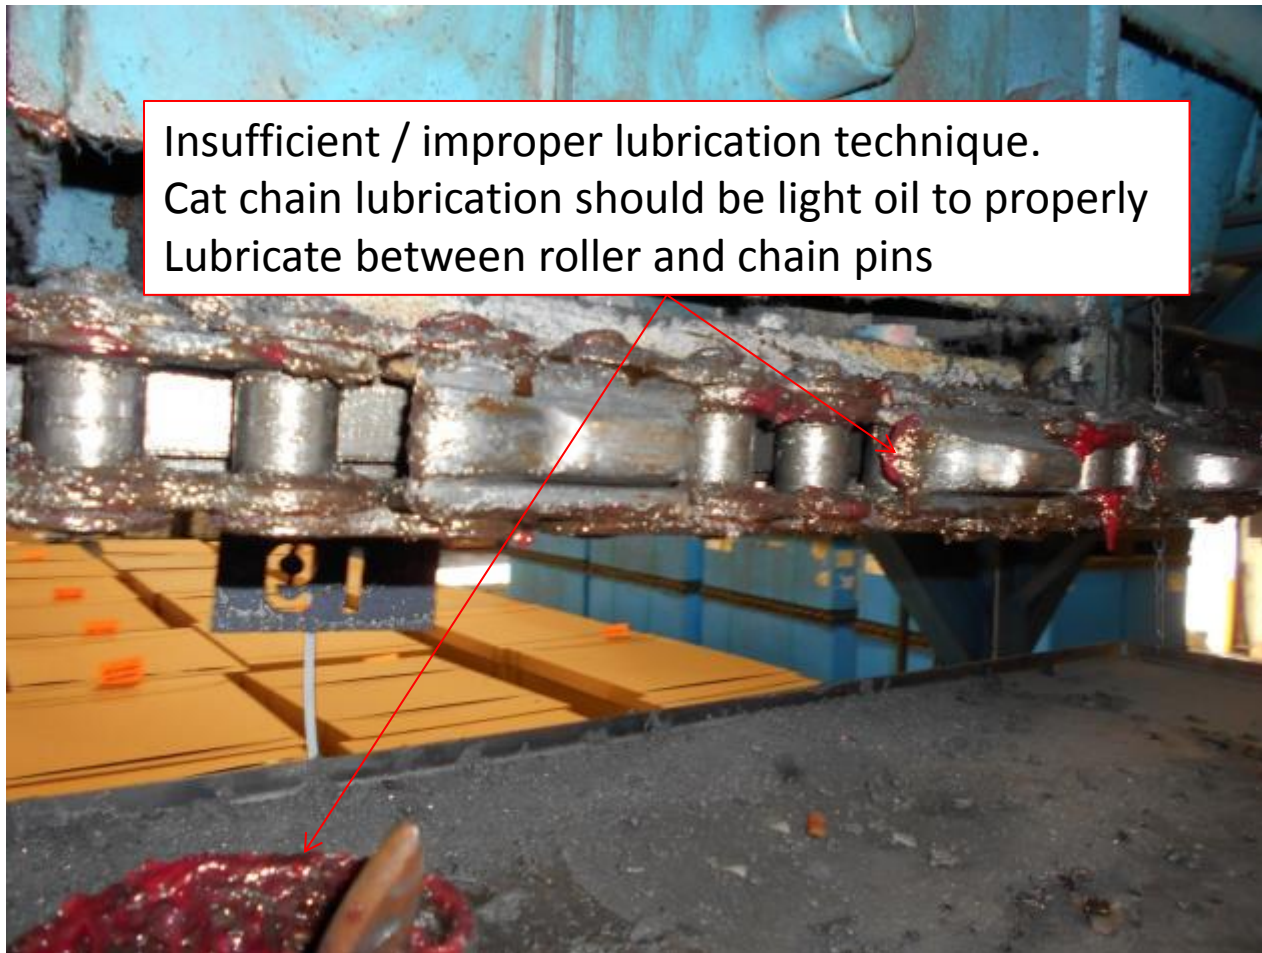
North conveyor drive (main unit)

Insufficient / improper lubrication technique.
Cat chain lubrication should be light oil to properly
Lubricate between roller and chain pins

- An active lubrication system is critical for all paint conveyor systems. Installing a working system will greatly help alleviate the current torque overload issues.
- **An active automatic conveyor chain lubrication system should be the immediate top priority.**
- We recommend replacing all of the Graphalloy hubs on the traction wheels throughout the paint bake oven
- The north conveyor stand by drive unit is inoperable and at a minimum will require new cat chain sprockets, new back up bars, and a new cat chain

- We recommend replacing all conveyor drive (main and stand by on both north and south drives) cat chain sprockets, cat chains, and back up bars
- We recommend installation of an automatic cat chain lubrication system on all (4) drive units
- Due to lack of sufficient time to perform a complete system inspection we were unable to physically inspect all of the segment roller turns in the system.
- We recommend that all roller nests are physically inspected for worn out bearings and that new replacement rollers are installed and lubricated where deemed necessary.
